SCS Engineers performed a Phase I Environmental Site Assessment (ESA) of the property known as the Swan Island Lease Property located on the Portland Shipyard in the vicinity of North Channel Avenue, Portland, Oregon 97217, hereafter referred to as the subject property. The purpose of the investigation was to evaluate the potential presence of hazardous materials, substances, waste and recognized environmental conditions. In addition, this investigation was performed in order to evaluate the potential for such materials to have migrated onto the subject property from adjacent or nearby properties. The investigation included a limited inspection of the subject property, the exterior of adjoining properties, consultation with state regulatory offices, and review of appropriate federal, state, and local historical and environmental records.

This report provides the results of the Phase I Environmental Site Assessment (ESA) for the property known as the Swan Island Lease Property located on the Portland Shipyard in the vicinity of North Channel Avenue, Portland, Oregon (Figure 1), hereafter referred to as the subject property. Authorization for this assessment was provided by David La

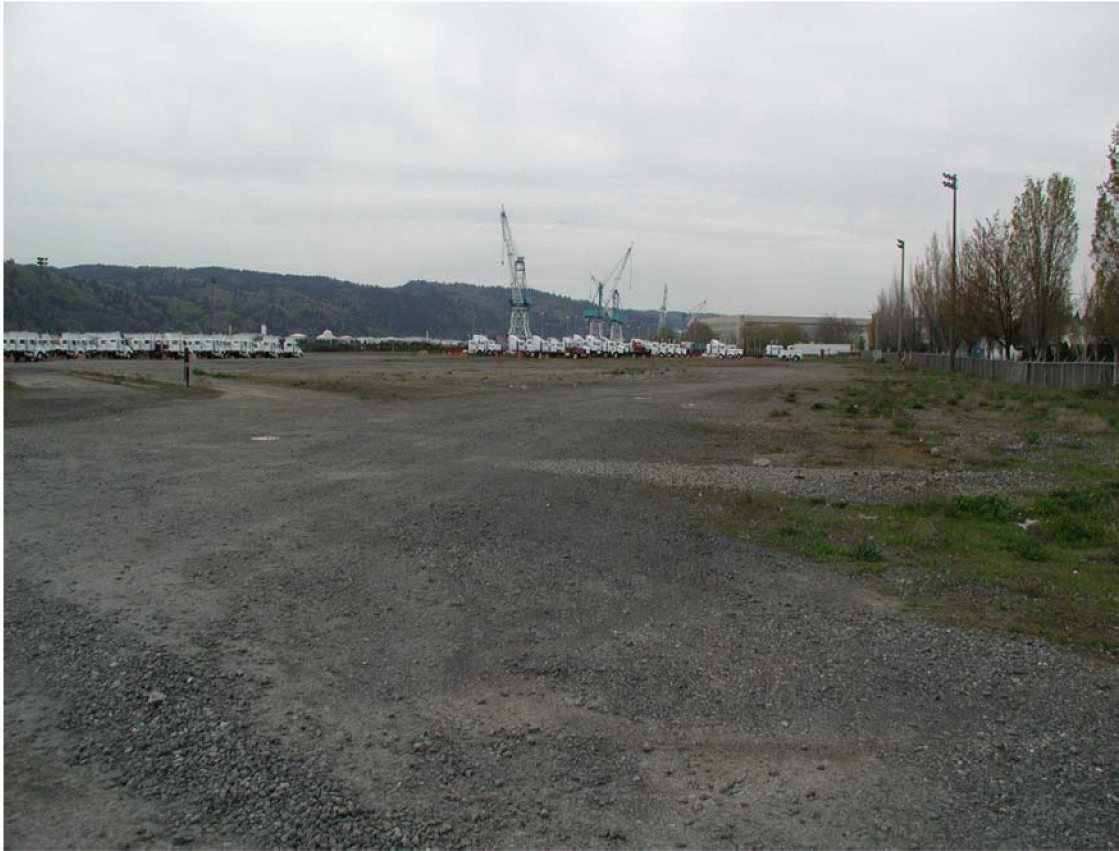
Photo 1. View to the west of the 20-acre North Channel Avenue parcel. Note Freightliner new truck overflow parking. (4/6/05)

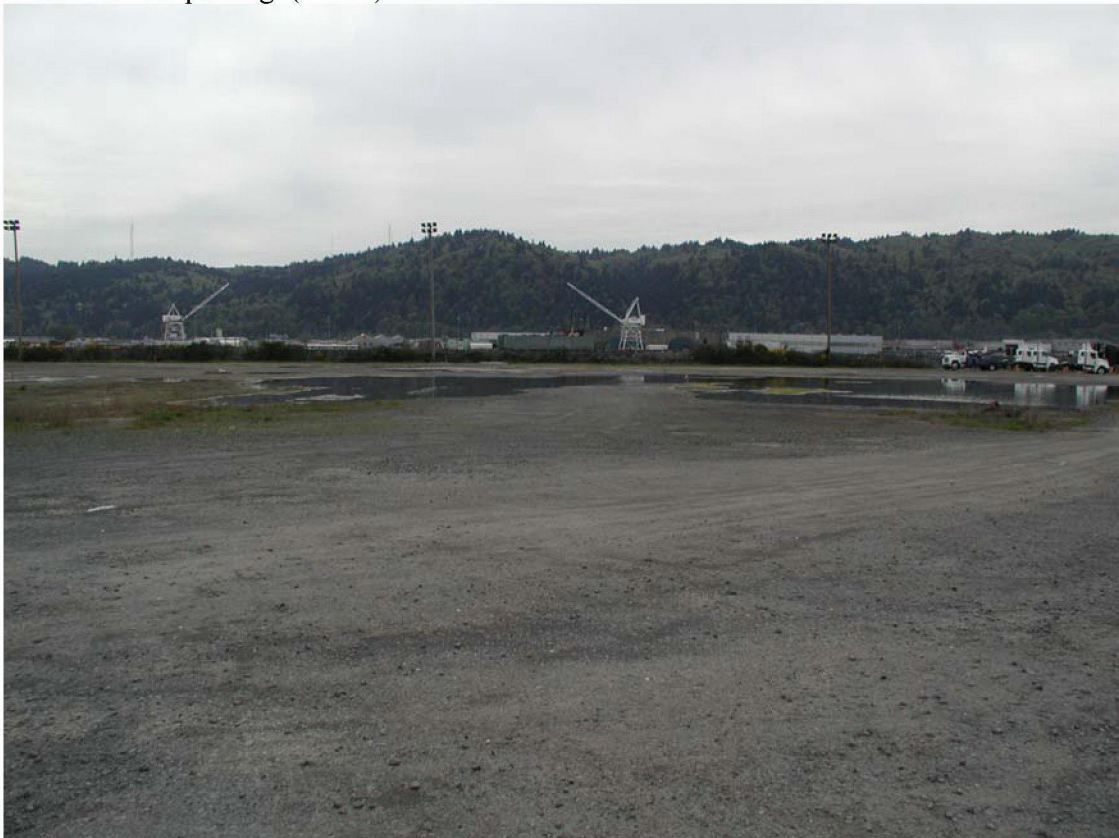
Photo 2. View to the south (toward the Willamette River) of the North Channel Avenue parcel. (4/6/05)

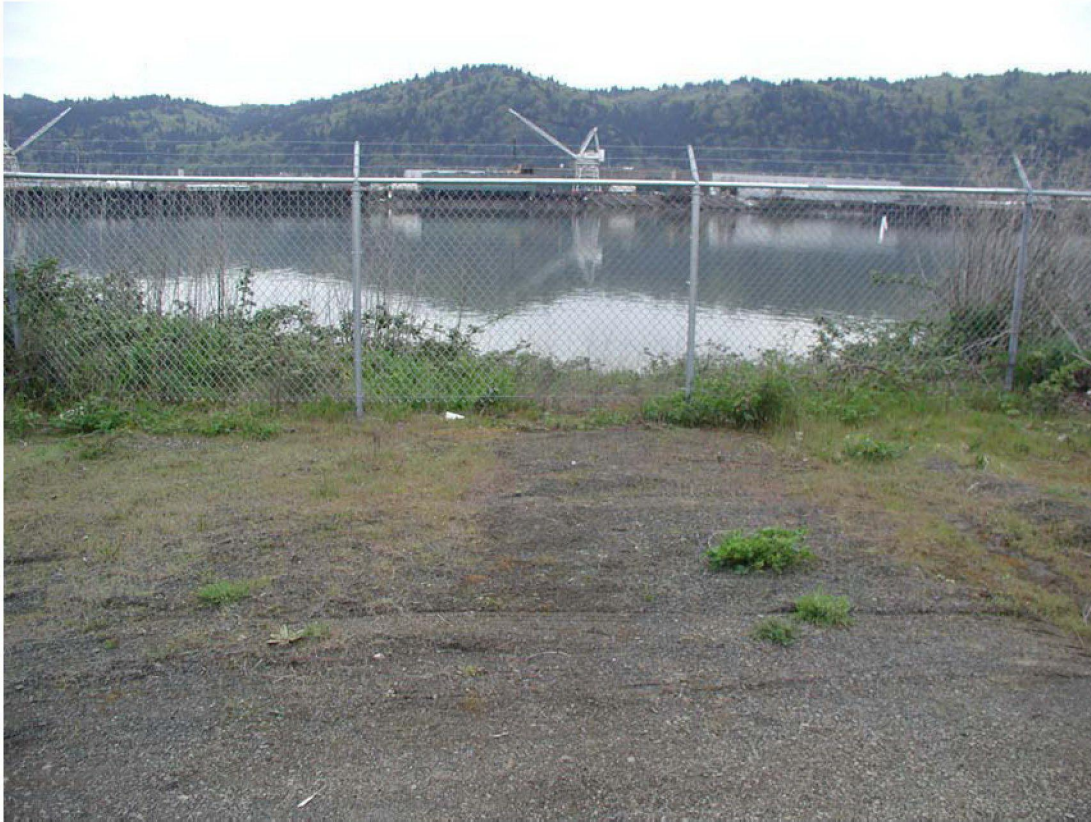
Photo 3. View to the south showing the Willamette River. The fence defines the southern border of the proposed Rinker lease. (4/6/05)

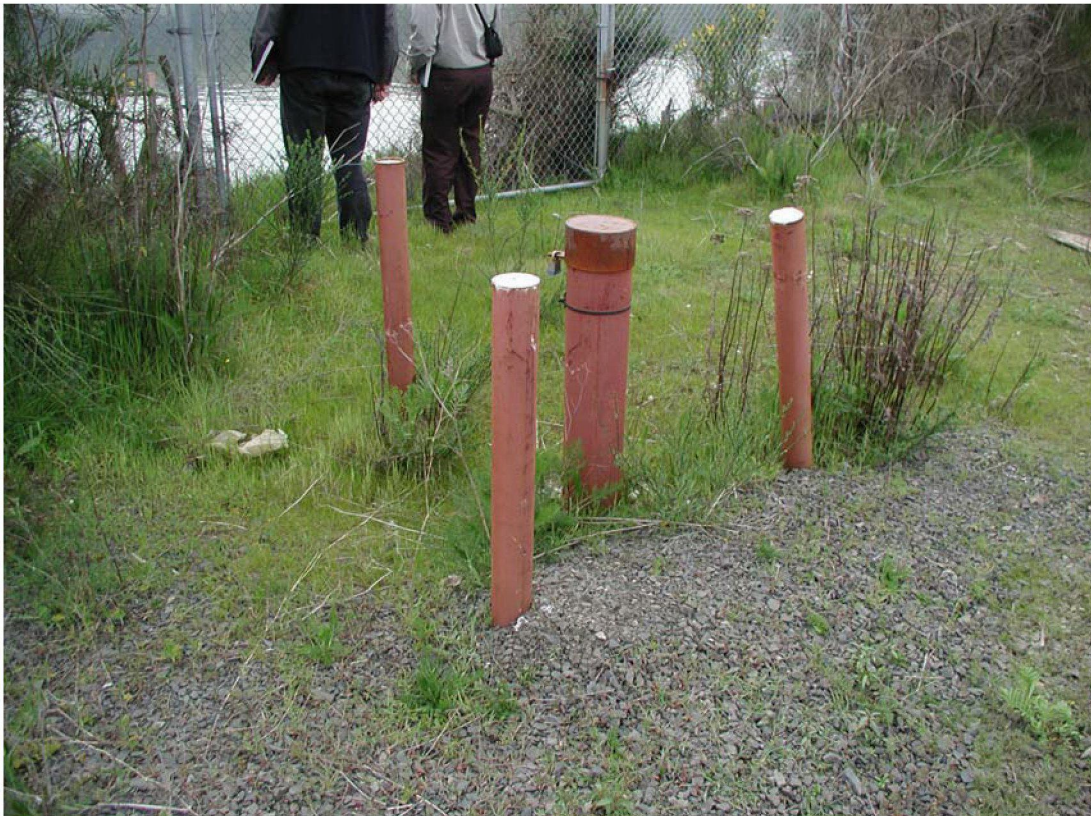
Photo 4. Groundwater monitoring well (MW-11) which is located along the southern border of the North Channel Avenue parcel.

After reviewing the Phase II quarterly groundwater monitoring results, DEQ suggested that groundwater monitoring be continued at a reduced scope and frequency. For MW-11, the sampling frequency would be reduced to a single annual event during seasonal low water conditions (September). Groundwater samples from this well would only be analyzed for total metals. Further sampling for vinyl chloride was not required by DEQ at MW-11.

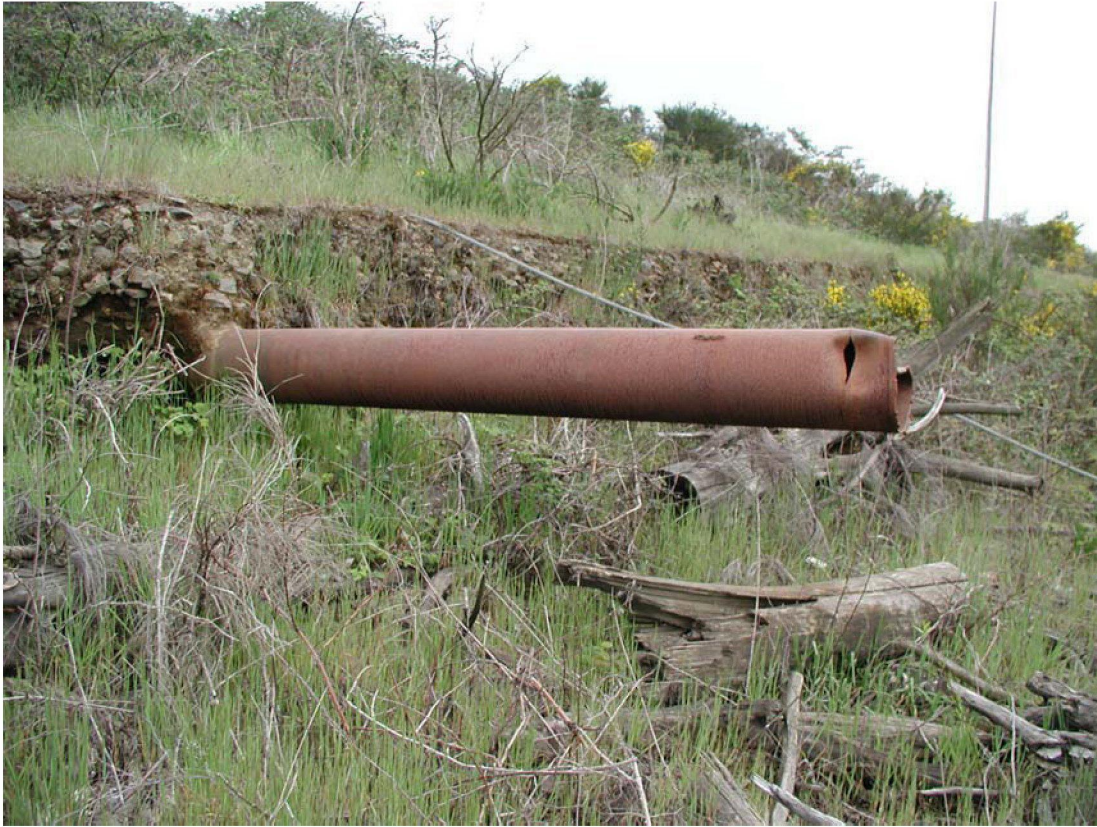
Photo 5. Suspected former storm water discharge pipe located along the south shoreline immediately outside of the North Channel Avenue lease.

Eight storm water catch basins are situated along the southern end of the MPL parcel. These catch basins connect to a storm water line that discharges along the Willamette River shoreline near the southwest corner of the NCFS parcel. Although no operating storm water catch basins are present on the NCFS parcel, several suspected old surface drains and discharge pipes (possibly associated with past site tenants) were observed on the parcel during the site inspection.

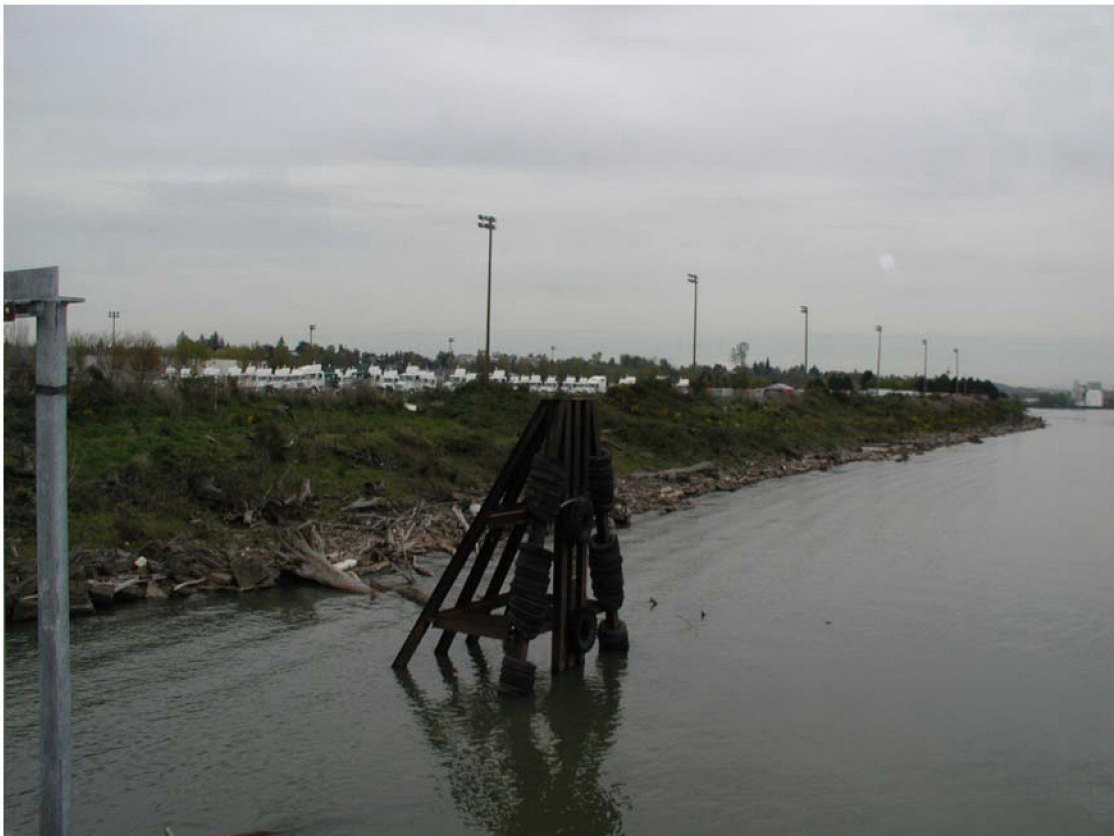
Photo 6. Easterly view along the southern shoreline of North Channel Avenue parcel.

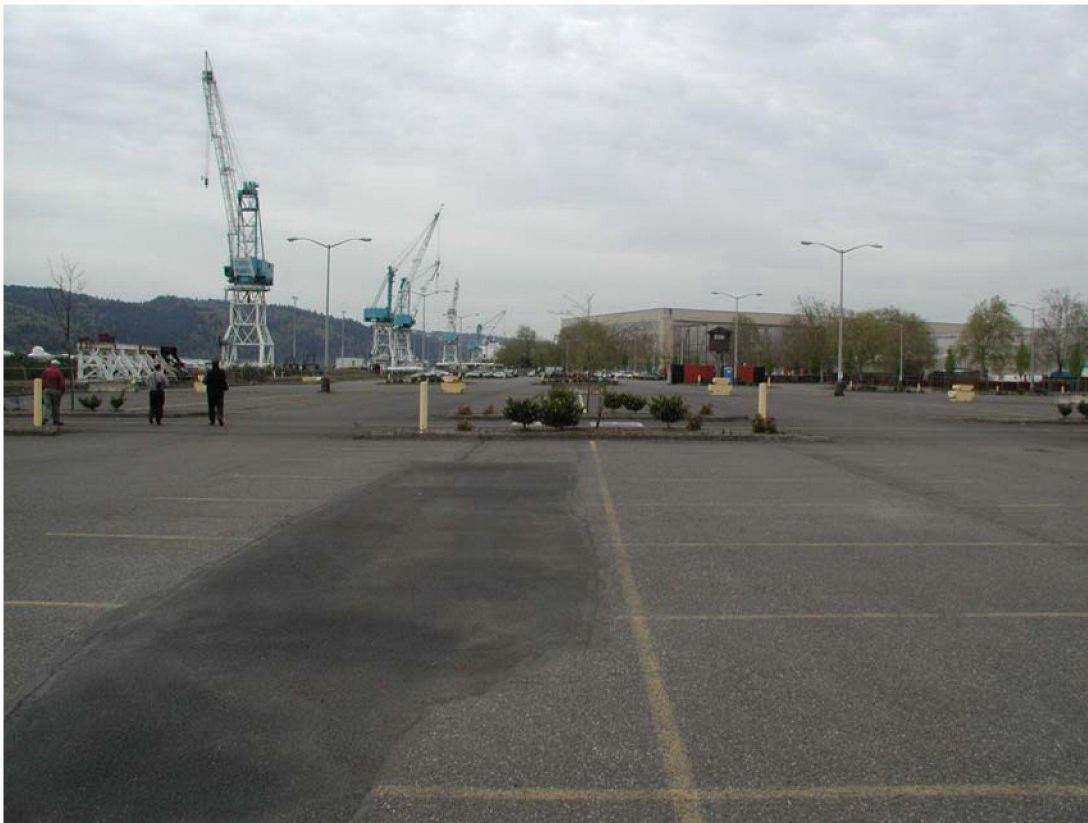
Photo 7. View to the west of the 5-acre Main Parking Area parcel located immediately west of the North Channel Avenue parcel. (4/6/05)

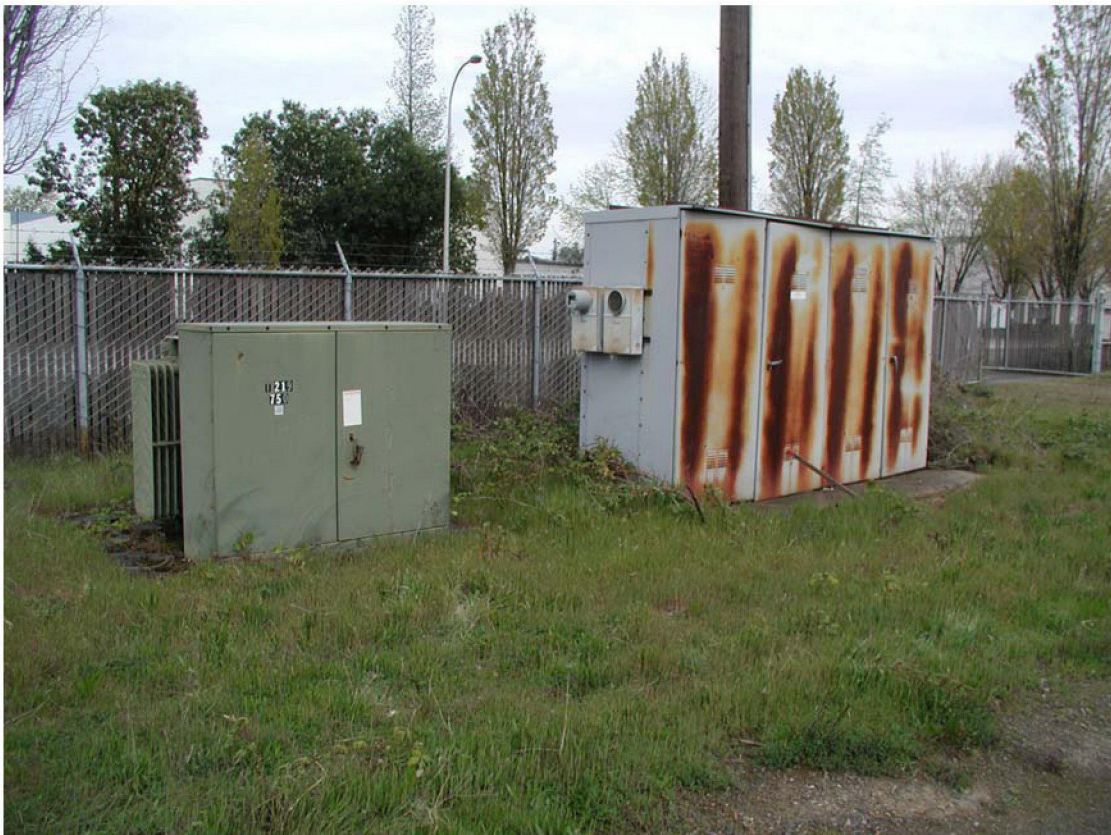
Photo 8. Electrical transformer and utility box located inside the north-central border of the North Channel Avenue parcel. The transformer was labeled “PCB-free”.
